Property Inspection Report

731 Tramway Drive, Milpitas, CA 95035

Donald Grenier
January 25, 2008
Report No. 120642

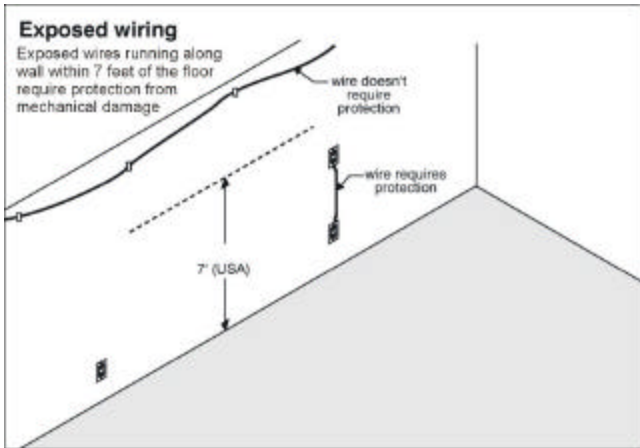
Illustration 7C

8. The damaged or loose exterior light fixture at the right side should be repaired or replaced as necessary.
9. We found exposed wiring at the garage walls below 7 feet. Even if insulated, we recommend all wiring be encased in conduit or otherwise protected in accordance with present standards. (See Illustration 7C)

- ! 7. We found exposed wiring at the garage walls below 7 feet. Even if insulated, we recommend all wiring be encased in conduit or otherwise protected in accordance with present standards. (See Illustration 7C)

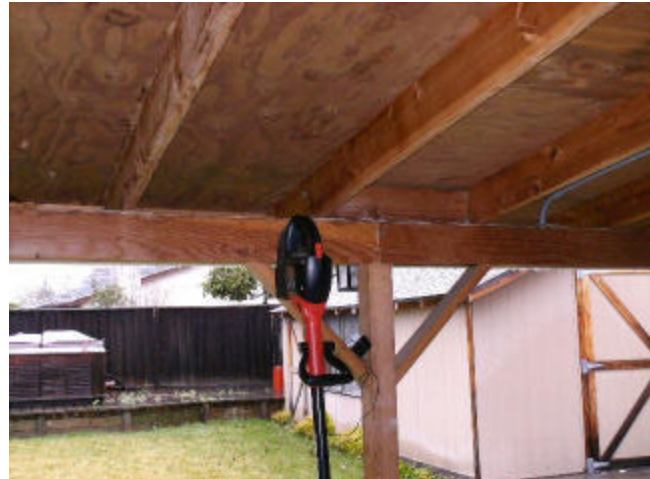
Picture 4

7. We found exposed exterior wiring at the rear patio cover wall. Even if insulated, we recommend all wiring be encased in conduit or otherwise protected in accordance with present standards. (See Picture 4)

- ! 8. We found exposed exterior wiring at the rear patio cover wall. Even if insulated, we recommend all wiring be encased in conduit or otherwise protected in accordance with present standards. (See Picture 4)

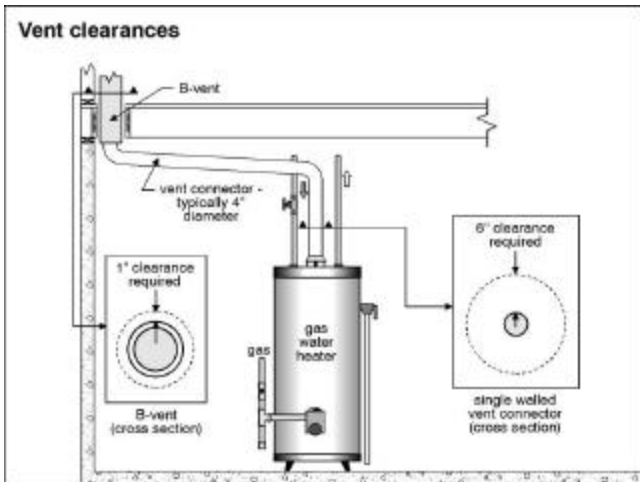
See Illustration 9Z)

17. There is insufficient clearance between the water heater exhaust flue and combustible materials. This condition should be improved. (See Illustration 9Z)

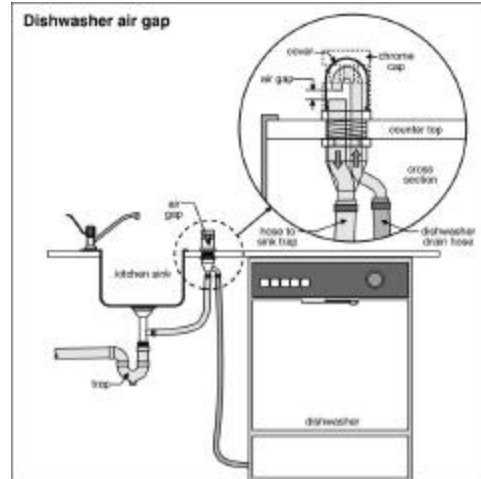
Illustration 4E

- ! 7. The dishwasher lacks an airgap device. Air gaps are standard equipment to assure a separation between supply and waste water of the dishwasher. It is advised that one be installed. (See Illustration 4E)
- ! 8. The power cord is not secured where it enters the bottom of the disposal and can be easily damaged. For maximum safety, we recommend the power cord be properly connected to the disposal. (See Illustration 4I)

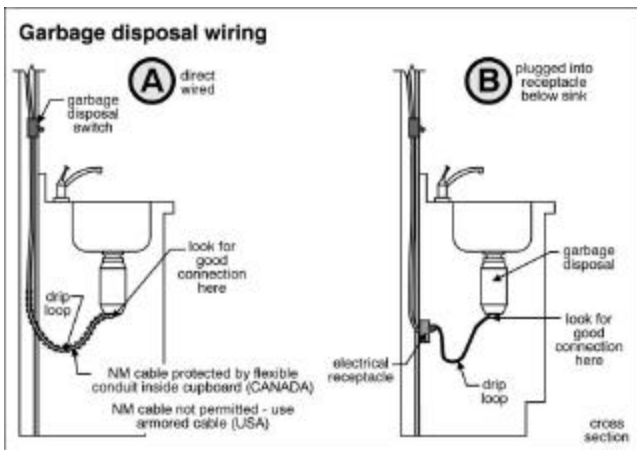
Illustration 4I

19. The power cord is not secured where it enters the bottom of the disposal and can be easily damaged. For maximum safety, we recommend the power cord be properly connected to the disposal. (See Illustration 4I)

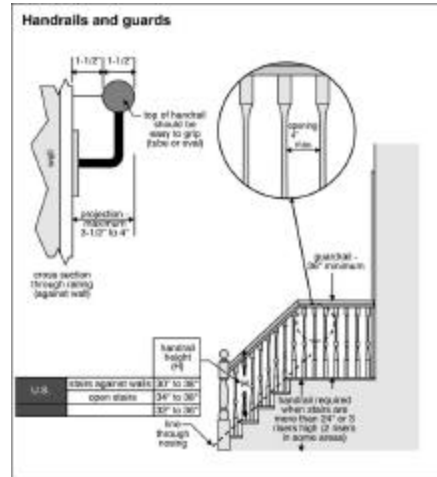
Illustration 7B

22. The openings in the stairway railing are larger than 4 inches. For improved safety it is recommended that the railing be altered for an opening of less than 4 inches. (See Illustration 7B)

- ! 3. The openings in the stairway railing are larger than 4 inches. For improved safety it is recommended that the railing be altered for an opening of less than 4 inches. (See Illustration 7B)
