Property Inspection Report

731 Tramway Drive, Milpitas, CA 95035

Donald Grenier
January 25, 2008
Report No. 120642

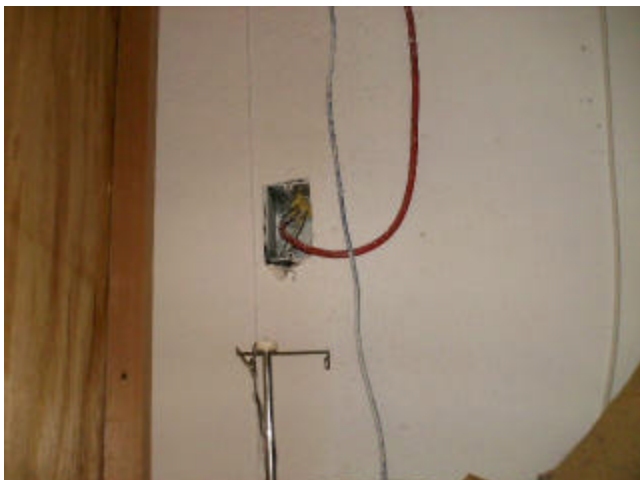
Picture 6

10. Exposed electrical connections or open junction box(s) in the garage should be improved. All electrical connections should be made inside approved junction boxes fitted with cover plates. (See Picture 6)

- ! 14. Exposed electrical connections or open junction box(s) in the garage should be improved. All electrical connections should be made inside approved junction boxes fitted with cover plates. (See Picture 6)
